WNMU MUSEUM ADJUSTS HOURS, ENTRANCE FOR VISITORS

Silver City, NM – A recent partial ceiling collapse at the main entrance of Fleming Hall is causing WNMU Museum visitors to enter the building at a North side entry on Alabama Street.

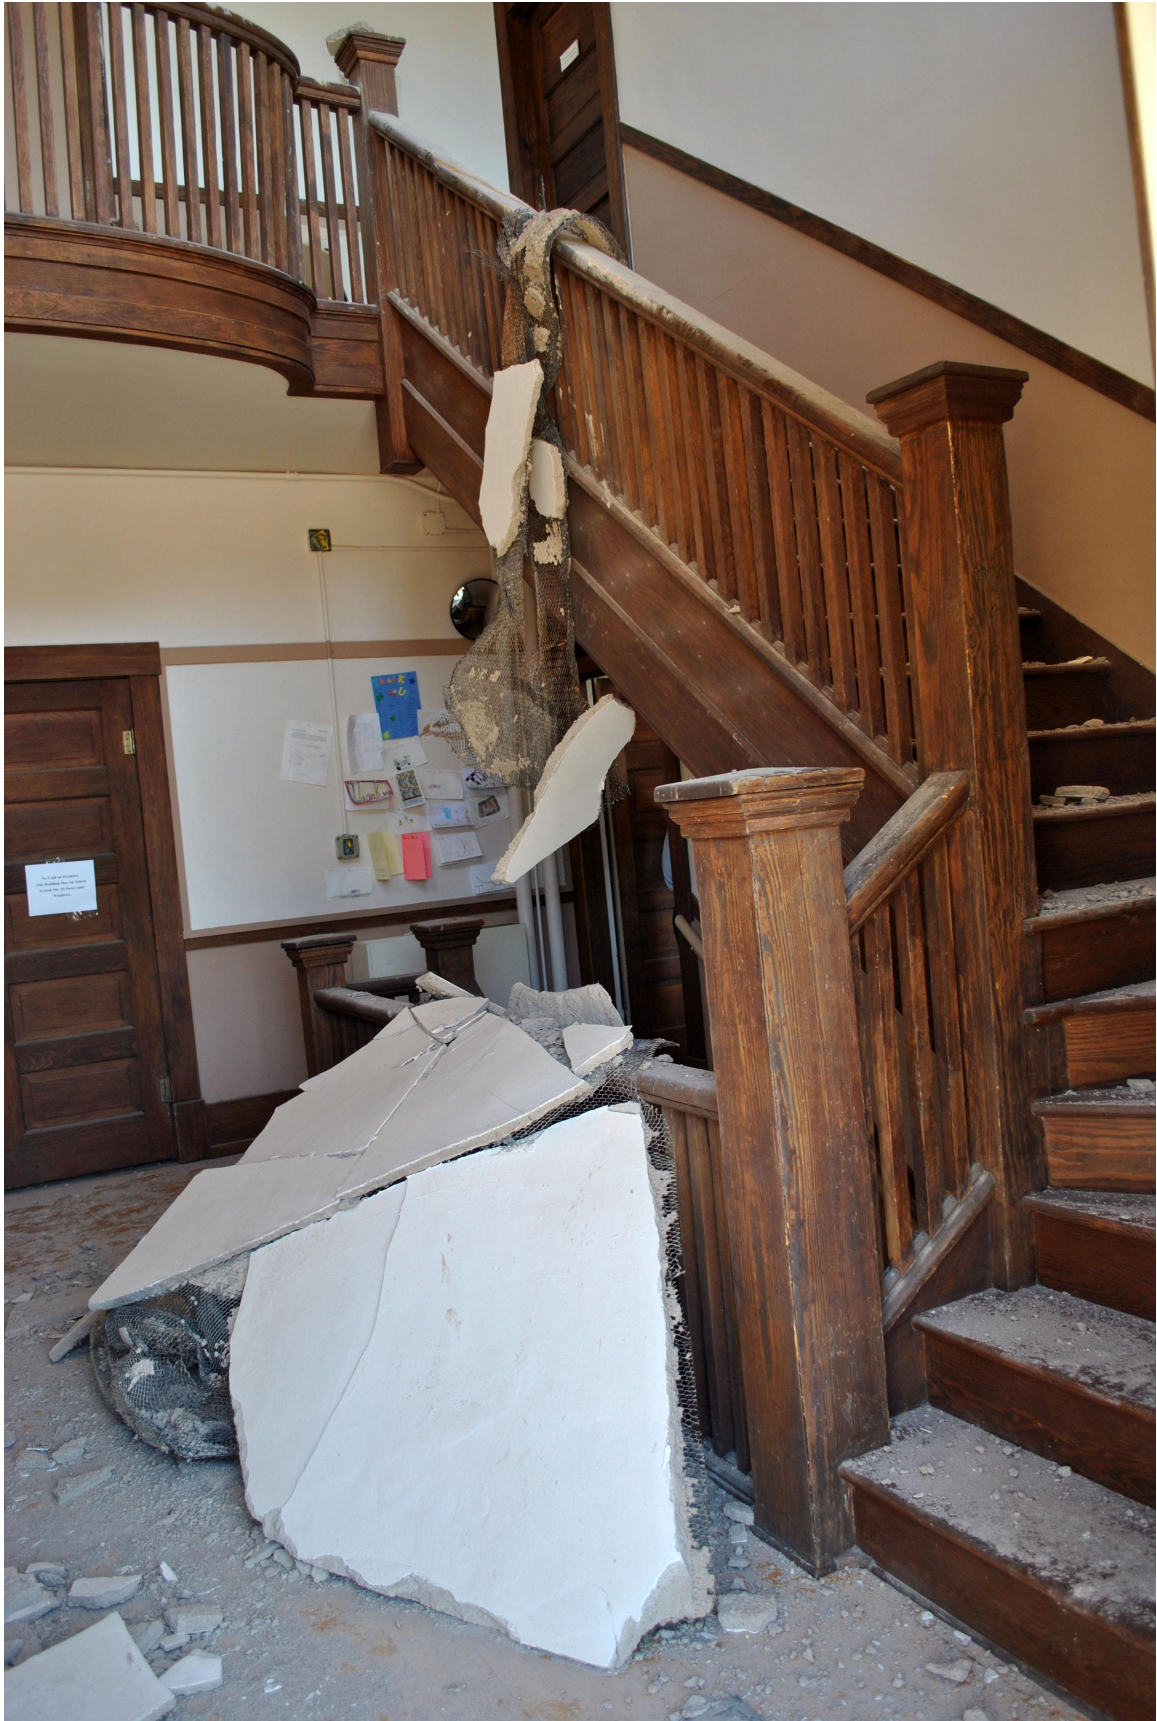
“During inspection of the ceiling remnants last week by engineers, the University architect, and others, it was found that the ceiling collapse is due to plaster failure,” said WNMU Museum Director Dr. Cynthia Bettison. “The Main Entry Foyer ceiling was constructed 96 years ago by securing wire mesh to the 2 inch x 8 foot/10 foot joists with ½ inch staples.”

The plaster, consisting of quartz sand, and pig and horsehair, was applied to the wire mesh by hand and is up to 3 inches thick in some places.

The ceiling collapse caused significant damage to the eastern section of the University Museum’s wood grand staircase, splitting the banister in several locations and scraping/removing sections of wood in other areas. The recently refinished Main Entry

Foyer maple floor and east section of the foyer balcony floor were scraped and dented by failing plaster. A wall heater, installed in the 1960s, located on the east side of the foyer balcony near the Director's Office entrance, was pulled from the wall and destroyed. No water or steam from the steam heat system was released.

The incident occurred while the WNMU Museum was closed on Wednesday, May 11. No staff or visitors were in the area and no one was injured. WNMU Maintenance workers cleaned the area of plaster on Thursday afternoon and Friday morning enabling the remaining ceiling to be secured and to prevent further collapse and damage to the building.
